Procedure to Write the Flash File.

If after an update, your Contact List is missing 2 Icons you will need to reload the Logo File to the radio

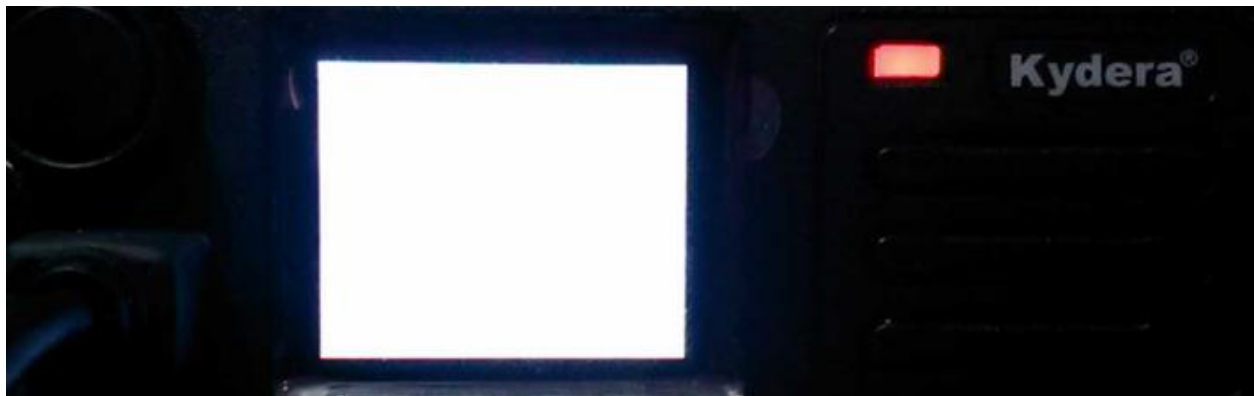
Put your radio in DFU mode by Holding P1 and Power UP.

Your radio will look like this.

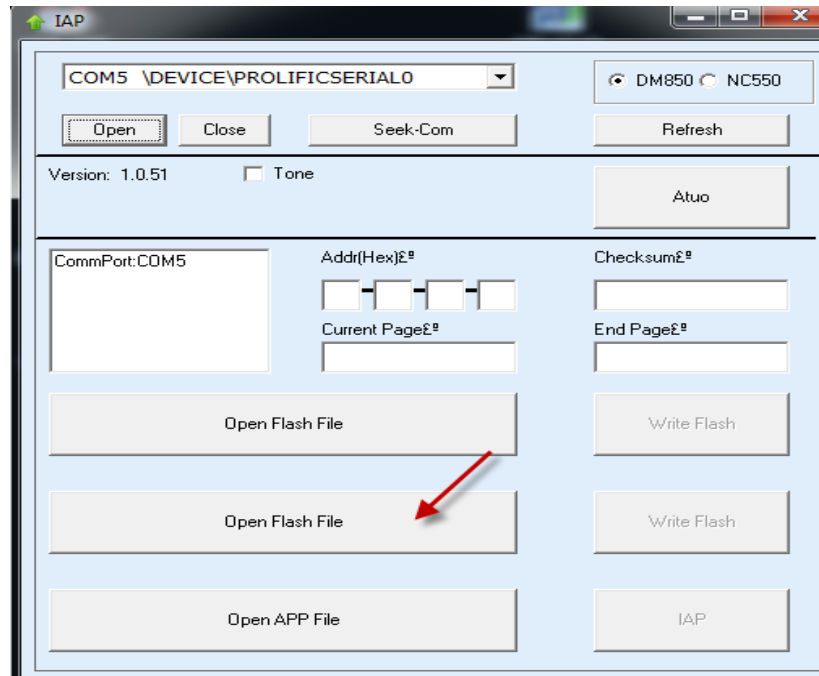
Then. Open your IAP and and Open Flash File
And browse to the location of your Flash File.

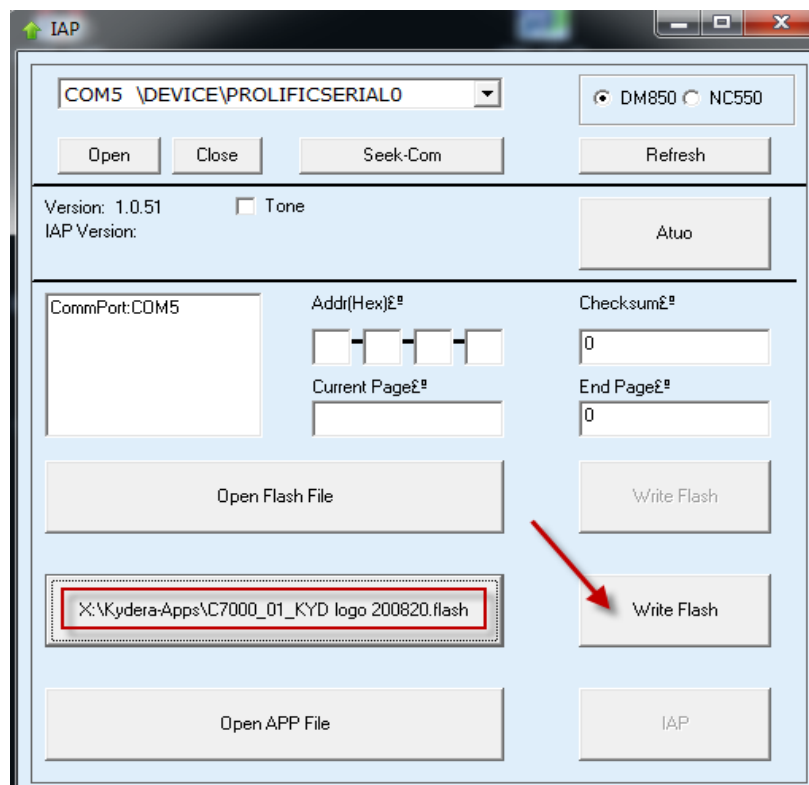
Then Write Flash

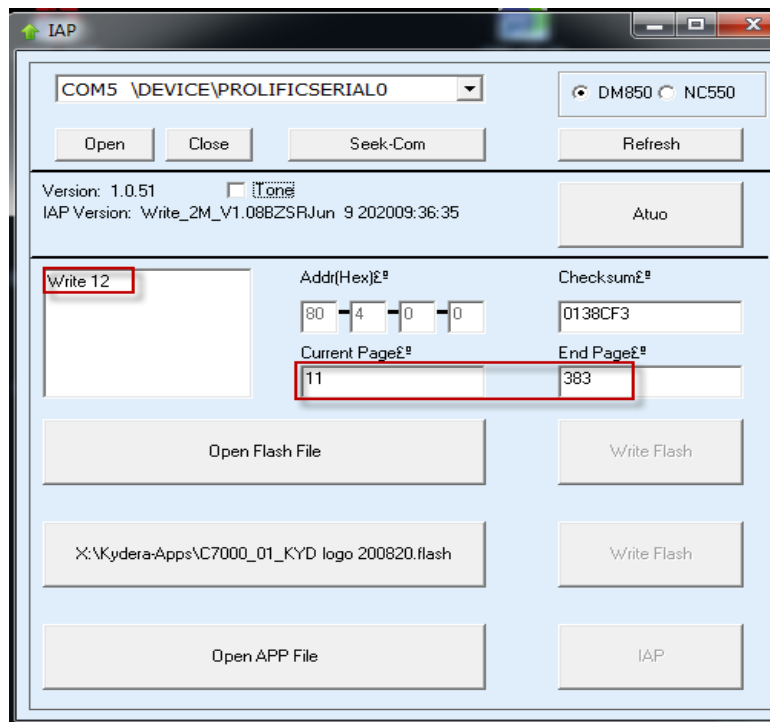
You have 383 block to write.

Write 12 Addr(Hex) 80 4 0 0 Checksum 0138CF3

Current Page 11 End Page 383

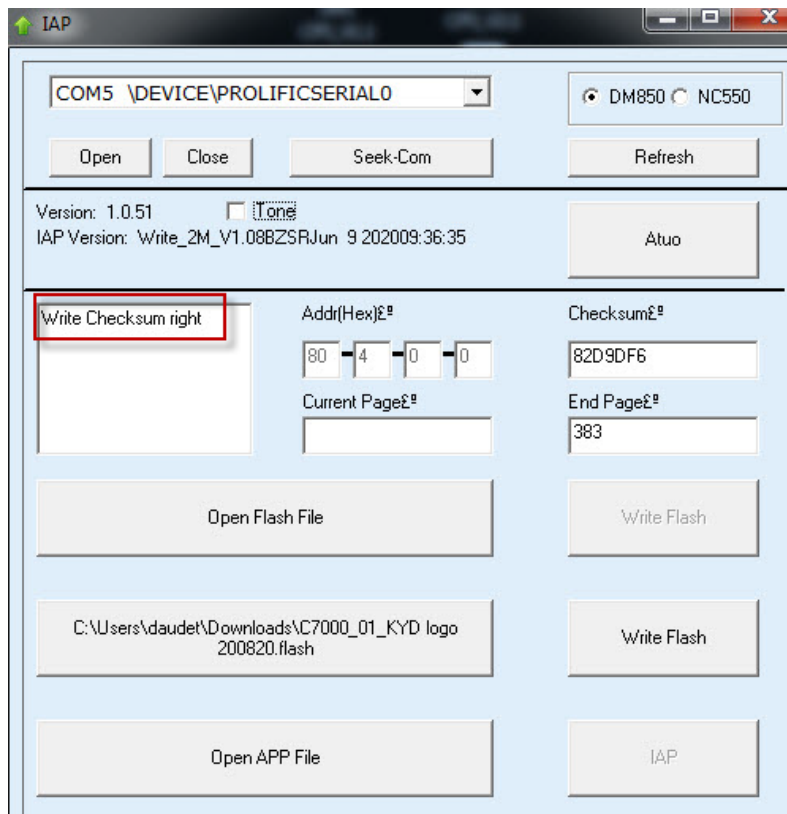
Once done you will get the message Write Checksum Right

Write Checksum right Addr(Hex) 80 4 0 0 Checksum 82D9DF6

**But the radio will not Power OFF by itself.
You need to power off to get out of DFU Mode.**

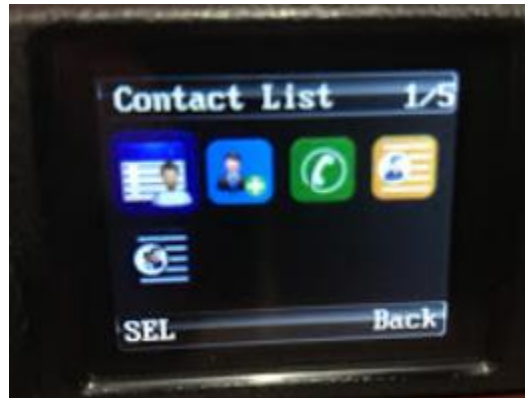
**Then Power it back up
Then your Contact List should look good.**
